Marin Environmental, Inc.

8 September 1998

Re: *Monitoring Well Installation, Soil and Ground Water Sampling,
Floor Drain Closure, and Waste Drum Sampling
Monty's Repair Shop, Swanton, VT* 98-2464

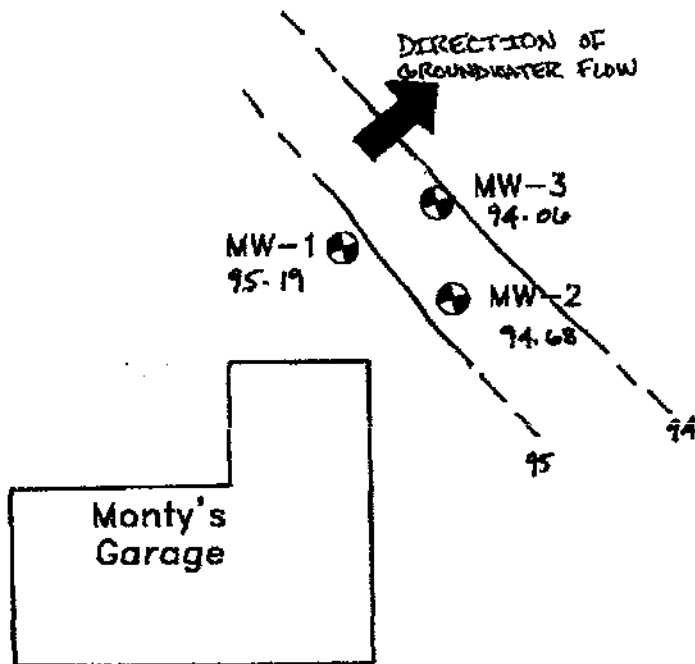
Marin Environmental, Inc. 1700 Hageman Ave. Colchester, VT 05446 (802) 655-0011	
SITE: MONTY'S REPAIR SHOP SWANTON, VT	
TITLE: FIGURE 3. GROUNDWATER CONTOUR MAP	
LEGEND:

On 24 August 1998 four temporary monitoring wells were installed in the area northeast and downgradient of the on-site floor drain (Figure 3). The wells were installed by pre-probing a ¼" hole with a Bosch SDS-Max hammer drill and KVA Hefty soil-gas rods. Refusal was encountered at all three well locations at a depth of approximately 7.5 feet below ground surface (bgs). A hand-slotted ½" PVC well was then inserted into the pre-probed hole and backfilled with native material. Ground water in the unconfined surficial aquifer directly beneath the site appears to be flowing in an northeasterly direction. Water-level measurements and elevation calculations for 31 August 1998 are presented in Table 1. The ground-water contour map in Figure 3 was prepared using this data.

Well ID	Top of Casing Elevation	Depth of Well (feet, TOC)	Depth to Water (feet, TOC)	Ground Water Elevation
MW-1	100.00	5.17	4.81	95.19
MW-2	99.57	6.67	4.89	94.68
MW-3	99.00	7.25	4.94	94.06

Results of ground-water sampling indicate non-detectable concentrations of VOCs by EPA Method 8260 in all three wells. Each monitoring well was sampled using 5/16" vinyl tubing by applying a vacuum and evacuating water directly to the sample container. The ground water samples were submitted to Endyne, Inc. of Williston, Vermont.
